Type B Accident  
Investigation Report  
of the  
July 25, 1997  
Contract Brush Cutter Injury  
on the  
Ashe-Marion #2  
500 kV Line

**B O N N E V I L L E**  
POWER ADMINISTRATION

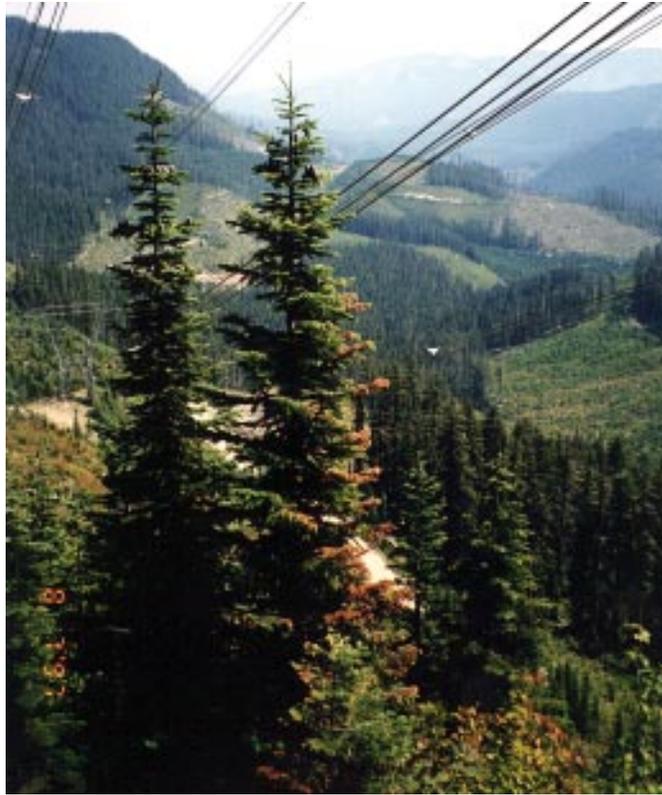
Exhibit 8 - Two trees adjacent to accident site, showing fire indication on the tree and proximity of trees to the overhead power line.

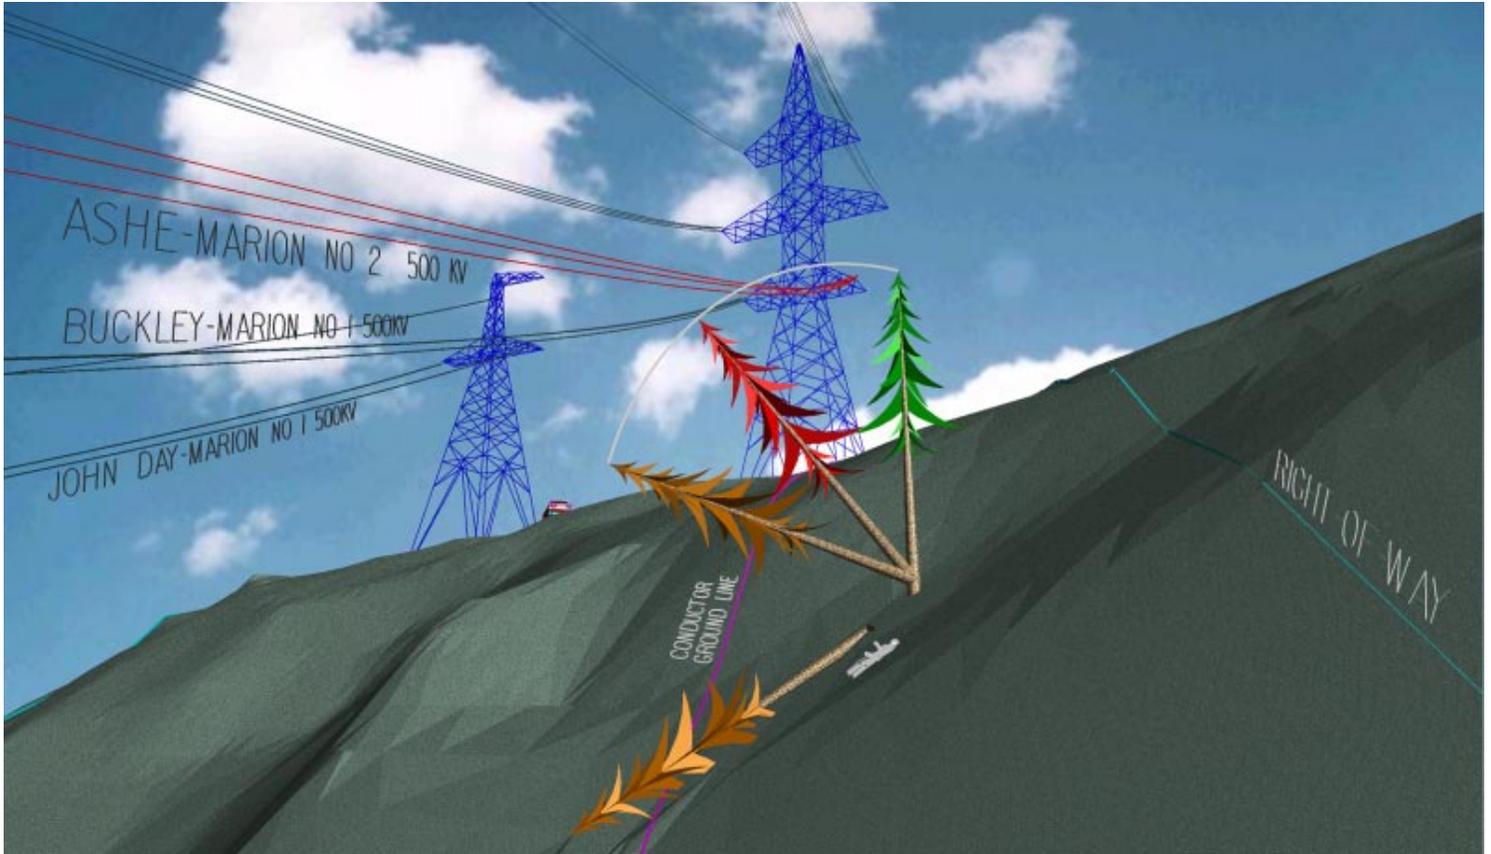
Figure 2 - Sketch of Accident Tree Fall Line

For the next 30 minutes, the brush cutter/victim cut brush and trees for approximately 60 feet, from the skid road down the steep slope. (See Exhibit 7) He then began to cut a white fir, approximately 34.5 feet tall with a base of 7 1/2 inches, that was one of four trees adjacent to the Ashe-Marion #2 500-kV transmission line. (See Exhibit 8) The brush cutter made a single cut into the uphill side of the tree, at the base. As the tree started to fall downhill, it broke away from the stump, leaving about a two-foot section of the cambium layer of the tree still attached to the butt of the tree. The tree fell close to the B-phase conductor on the Ashe-Marion #2 500-kV line. (See Figure 2) B Phase is the lowest conductor at this point on the line. The top portion of the tree arced from B phase-to-ground, then evolved to C phase, creating a phase-to-phase-to-ground fault. The two-foot section of electrically-conductive tree cambium was still attached to the tree butt as well as to the stump. This created a ground fault path. After the tree started to fall, the employee tried to step uphill, away from the falling tree. He stated that he froze, in a hunched-over position, due to a severe electrical shock received from the fault created by the current conducted through his lower body; the current entered through his left foot and exited from his right foot. Both hands remained on the chain saw with the saw blade in the air. After the faulted line cleared, the employee fell downhill, adjacent to the butt of the fallen tree. (See Exhibits 9-14)

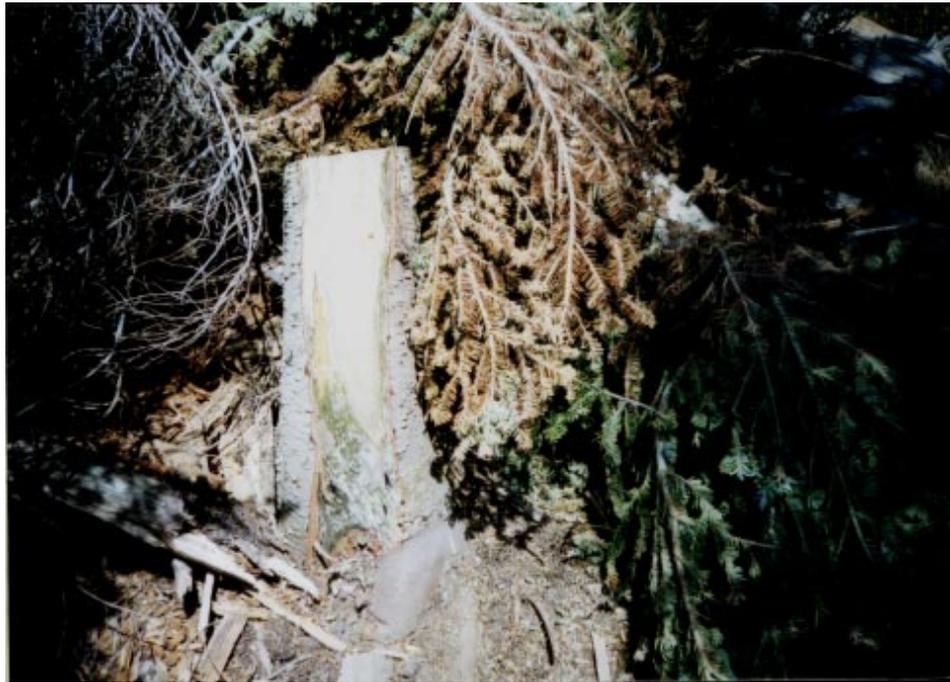
Exhibit 9 - Stump of fallen tree - victim would have been standing to the right of stump during falling process.

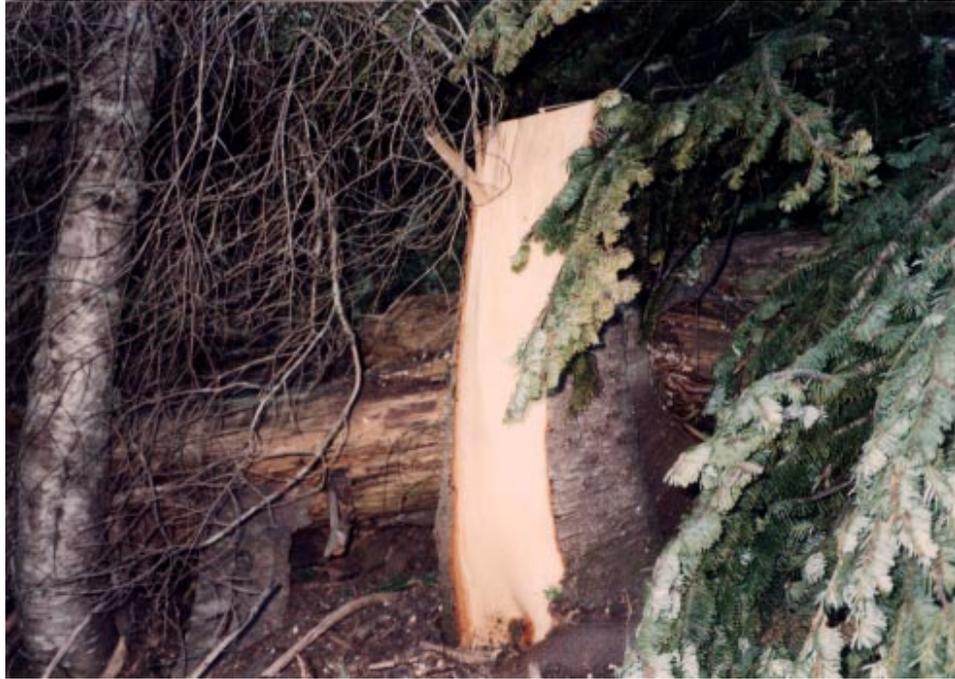
Exhibit 10 - Stump showing section that was torn off.

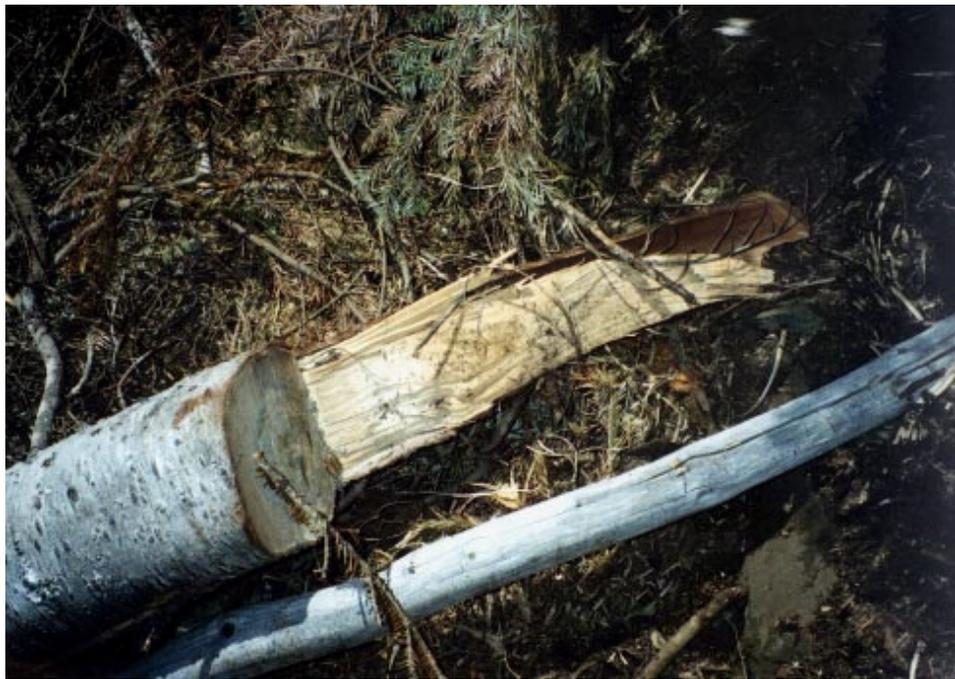
Exhibit 11 - Fallen tree with section of stump still attached.

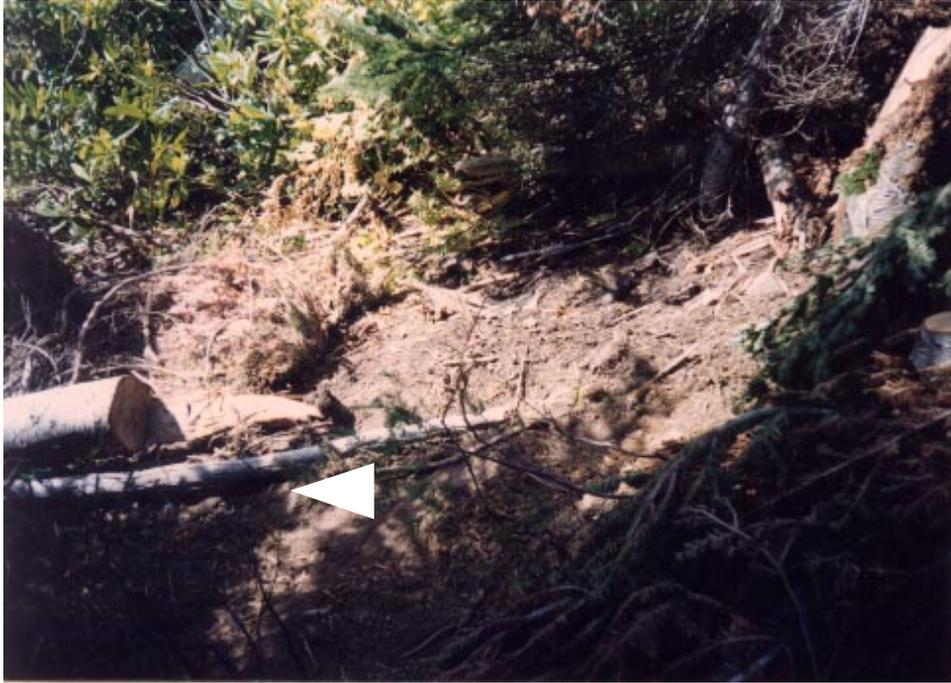
Exhibit 12 - Final separation distance between stump and fallen tree. Arrow pointing towards victim.

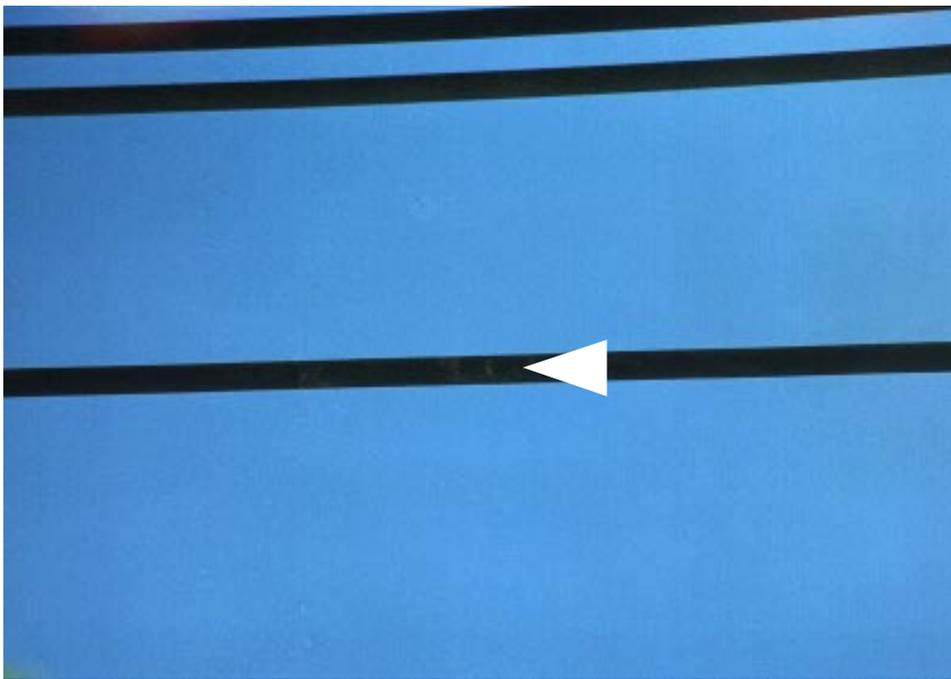
Exhibit 13 - Arc markings on B phase transmission line conductor.

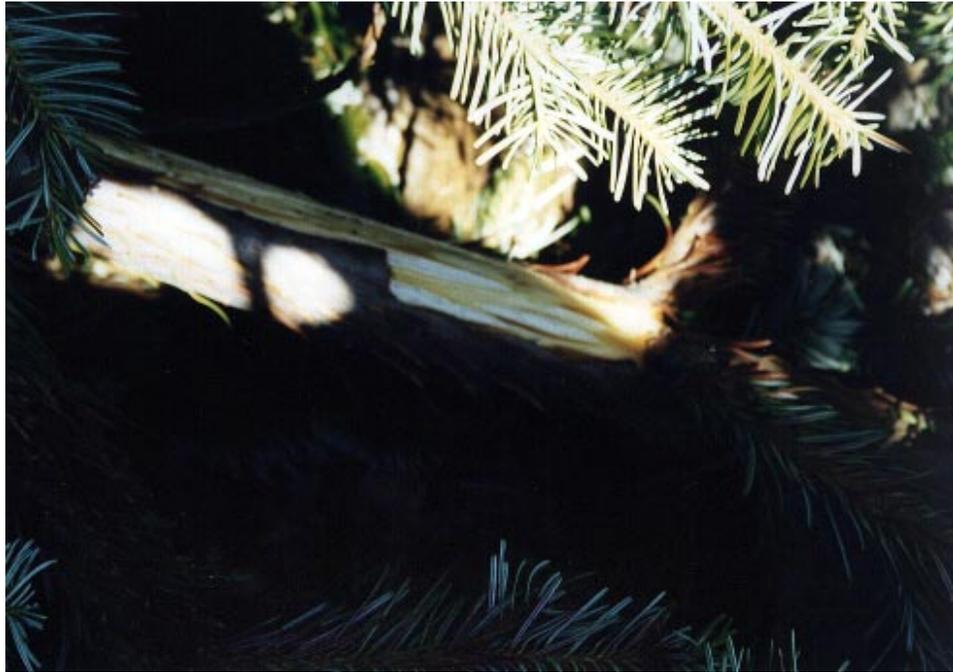
Exhibit 14 - Point of arc contact with tree and conductor, approximately 4 feet from tip of tree.

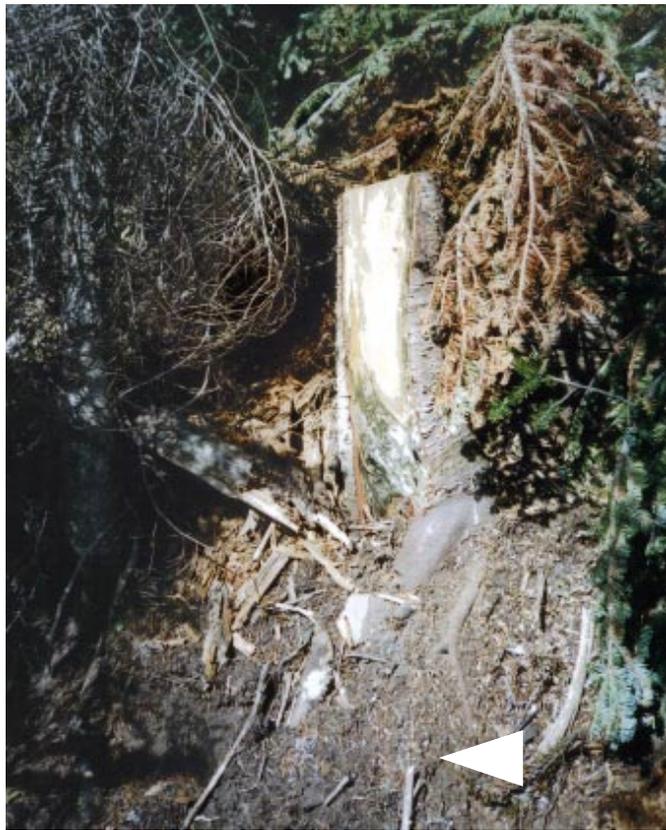
Exhibit 15 - Victim would have fallen downhill and to right of stump.

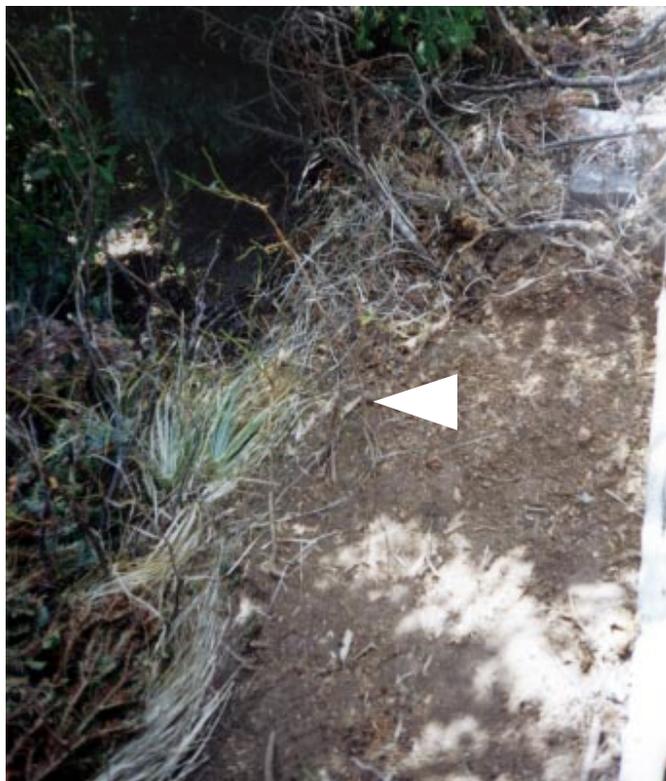
Exhibit 16 - Final location of victim, down hill from stump and adjacent to fallen tree.

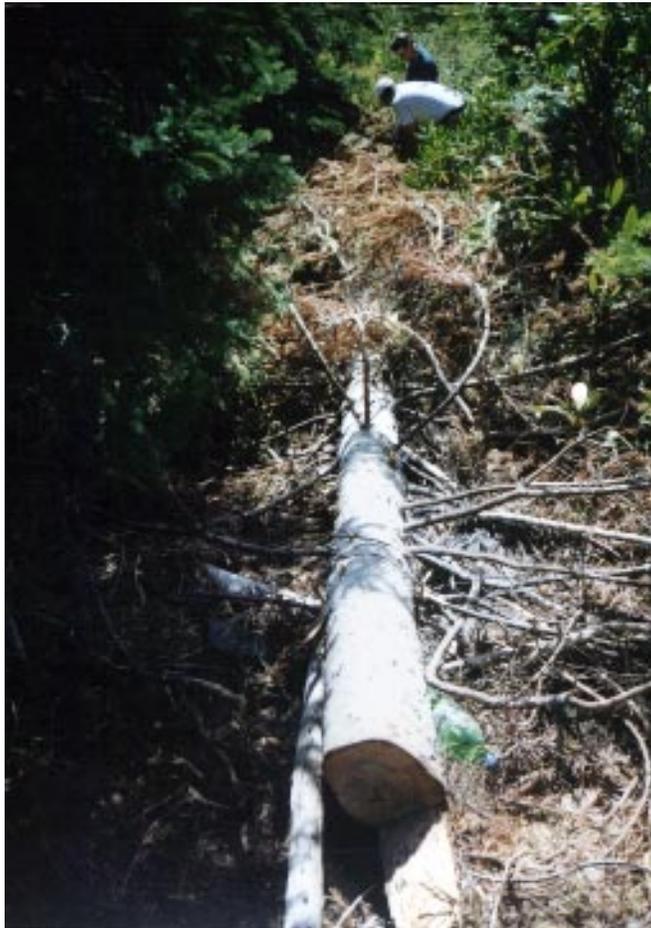
Exhibit 17 - Fallen tree from butt to tip of tree, where employee is located is point of electrical arc contact.

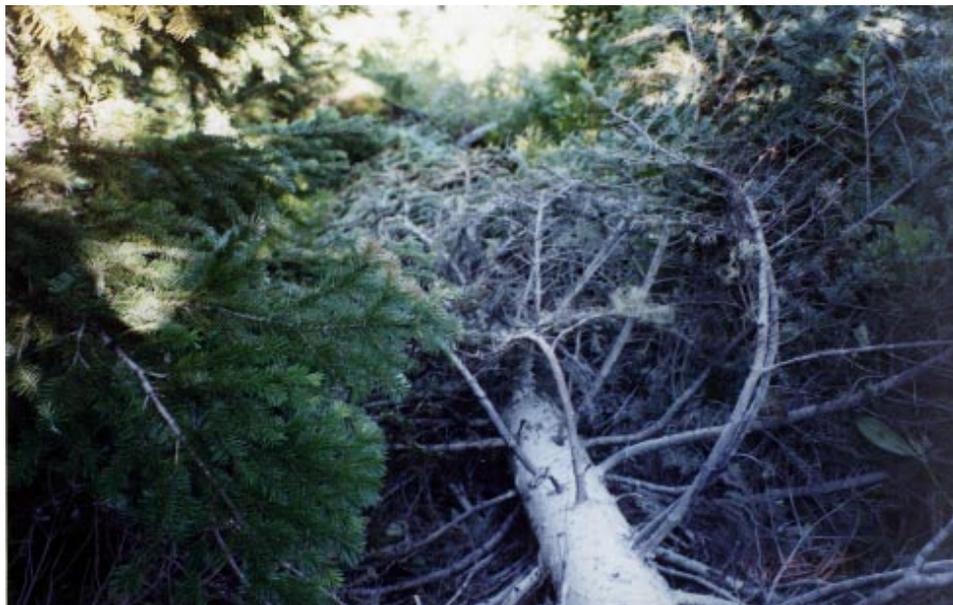
Exhibit 18 - Indication of fire on fallen tree.

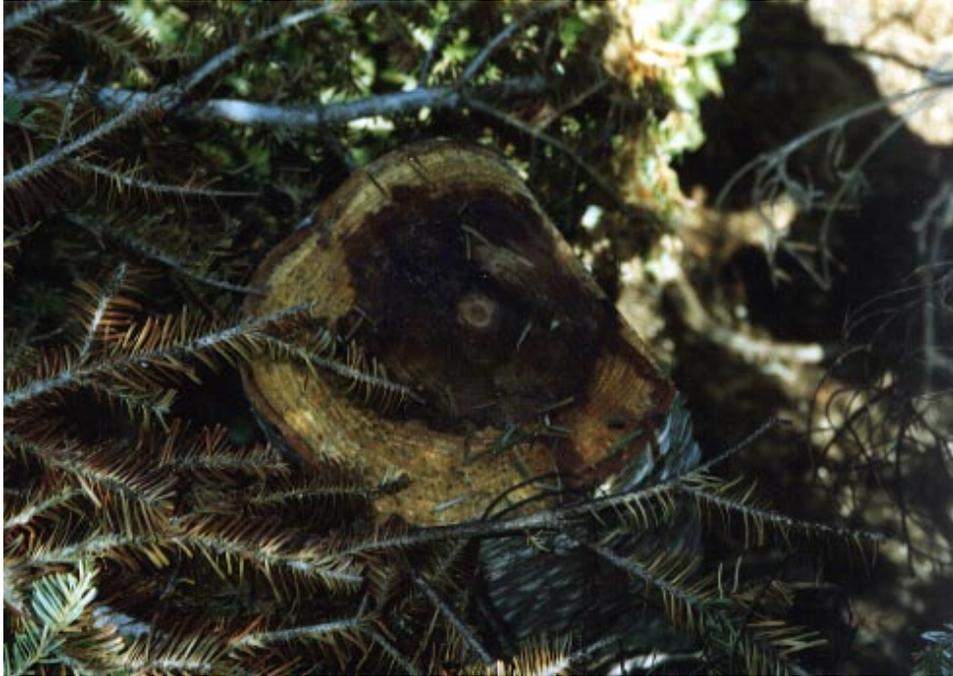
Exhibit 19 - Tree stump showing burn or heat indication.

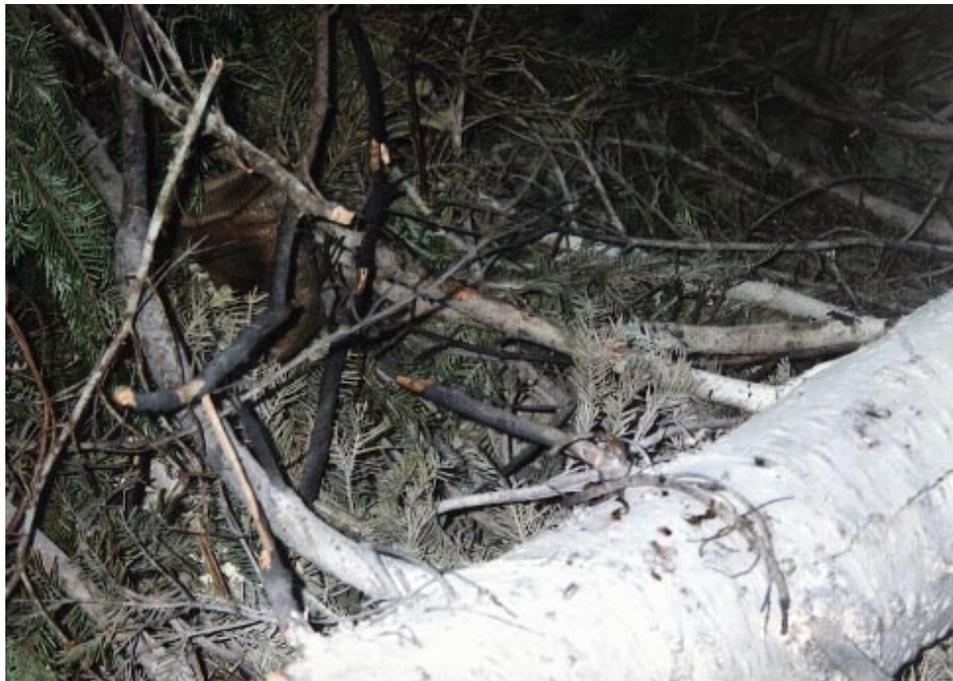
Exhibit 23 - Tree fire on fallen tree and adjacent to location of victim.

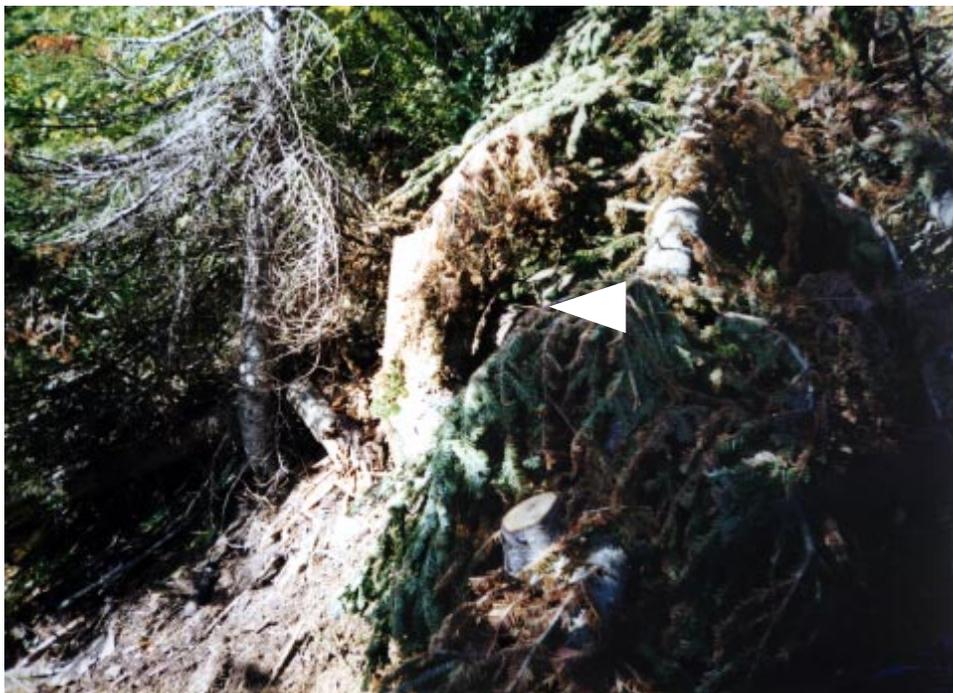
- **Falling Practices:** Visual inspection showed that none of the trees cut in the vicinity of the accident have undercuts. In his statement, the head foreman said he told the cutters to never fall any tree perpendicular to the power line; it always should be parallel. Employees were instructed to notify the head foreman, before cutting any dangerous trees or brush, if they encountered any questionable situation not previously identified as dangerous. The head foreman would then discuss any potential problems with the inspector and could request a hold order or a clearance if he judged it was needed. (See Exhibits 24-26)

Exhibit 24 - Where victim was standing when he fell the tree - No escape route - Poor tree falling practice.

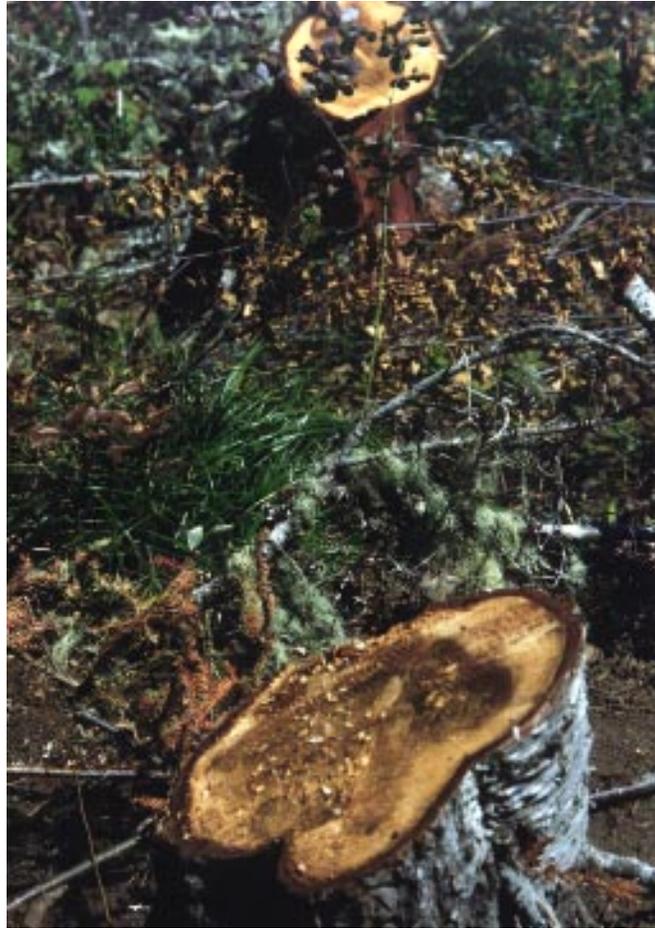
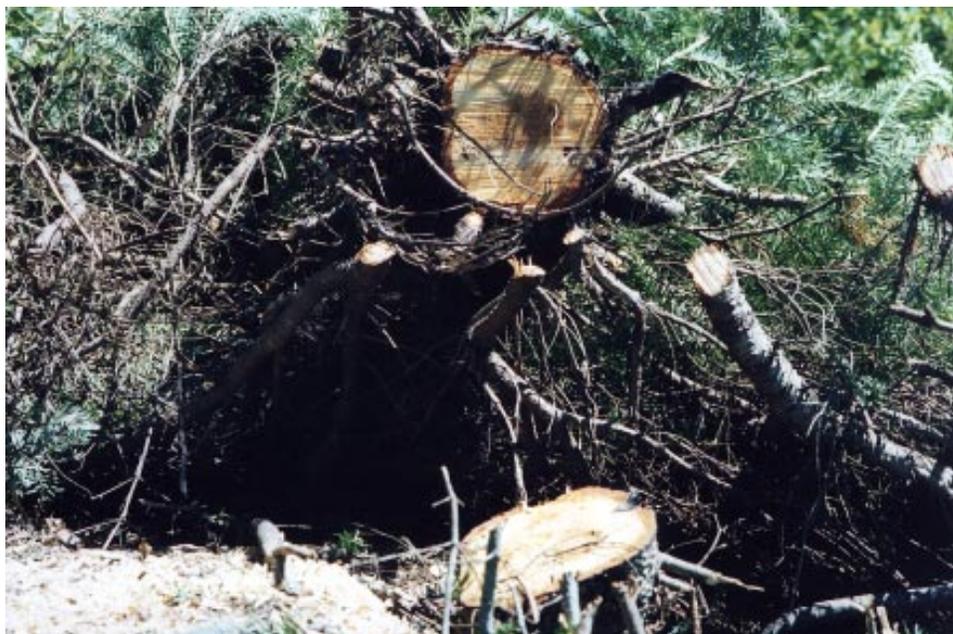
Exhibits 25 & 26 - Improper tree cutting/falling procedures.
